**Subject:** Tech Note

**Update Tech Note on RXT-1000 base chassis**

*Last Updated Dec 12, 2011*

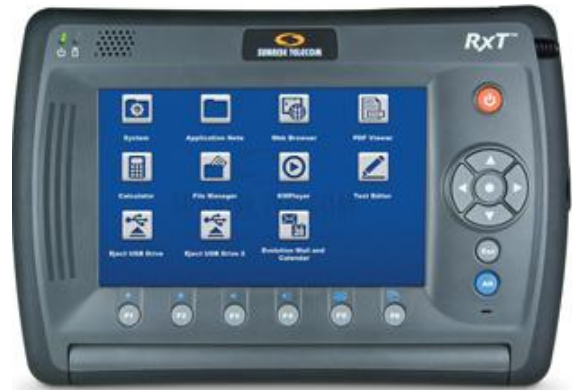
Recently we have been alerted that customers have experienced or noticed “hanging/freezing “of the base chassis (RXT-1000), leaving it in a suspended state where the Sunrise Logo remains displayed on the screen. We have identified that a certain type/brand of micro SD card can instigate the symptom and result in improper system functionality.

As a confirmed resolution to this issue, Sunrise Telecom has qualified the San Disk micro brand SD card as the standard for the RXT platform. Effective as of September 19, 2011 Sunrise has purged the inventory of the identified faulty micro SD cards. Units shipped prior to September 19, 2011 may have either shipped with the faulty micro SD or the San Disk micro SD card as they were both previously approved for use.

If the customer encounters the above stated symptoms, please contact technical support to log the appropriate case as well as further diagnose the reported issue. The replacement of the Micro SD card for a San Disk micro SD card can be done in the field, however Support or Manufacturing (SRS/SRT) will need to generate the proper Linux files on the Micro SD card and send it to the customer.
